ISOLDE CHAMBER STATUS

21st April 2017

Vacuum and Si-Det testing

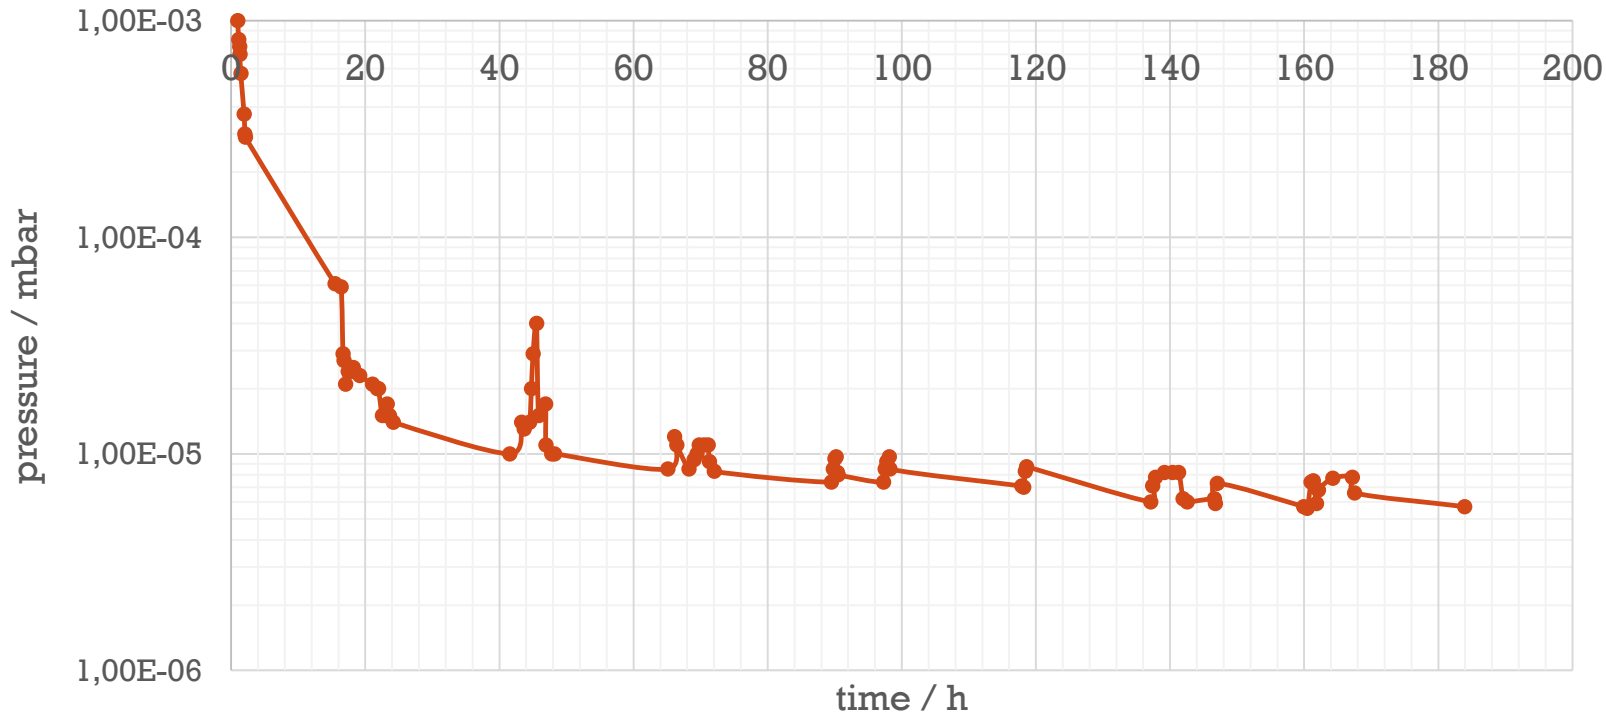
8th run - after crash - Zoom

Minimum:

p ~ 6.0E-06 mbar

T ~ -8.2° C

→ **Problem with Coolant → exchange it!**

→ **1E-05 took 40-50 hours → more moisture than usual**

**Establish
opening
chamber
Procedure!!!**

- Cooling off long before or heat up to +5 to +10 deg C

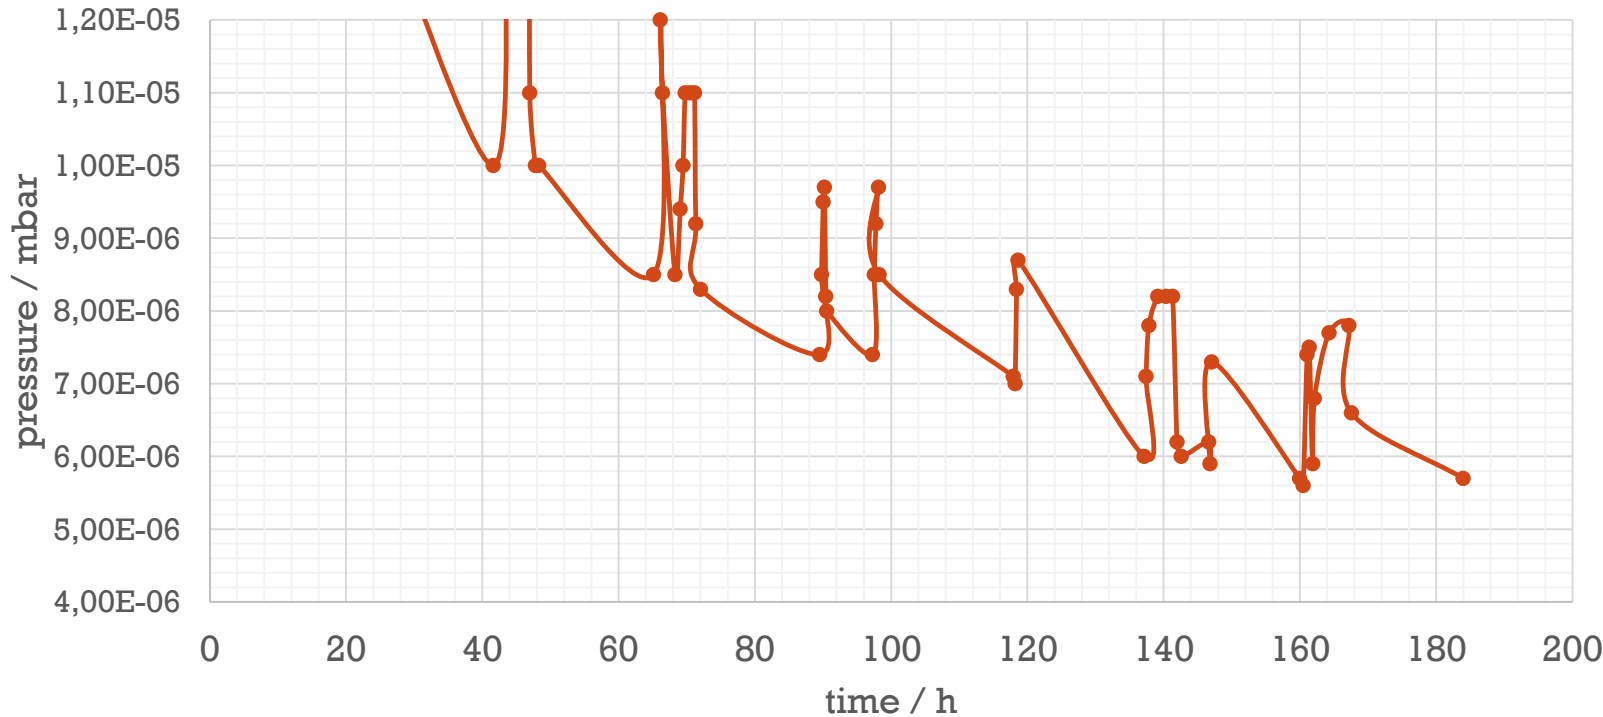
8th run - after crash - Zoom II

Minimum:

p ~ 6.0E-06 mbar

T ~ -8.2° C

→ **Problem with Coolant → exchange it!**

→ **1E-05 took 40-50 hours → more moisture than usual**

**Establish
opening
chamber
Procedure!!!**

- Cooling off long before or heat up to +5 to +10 deg C

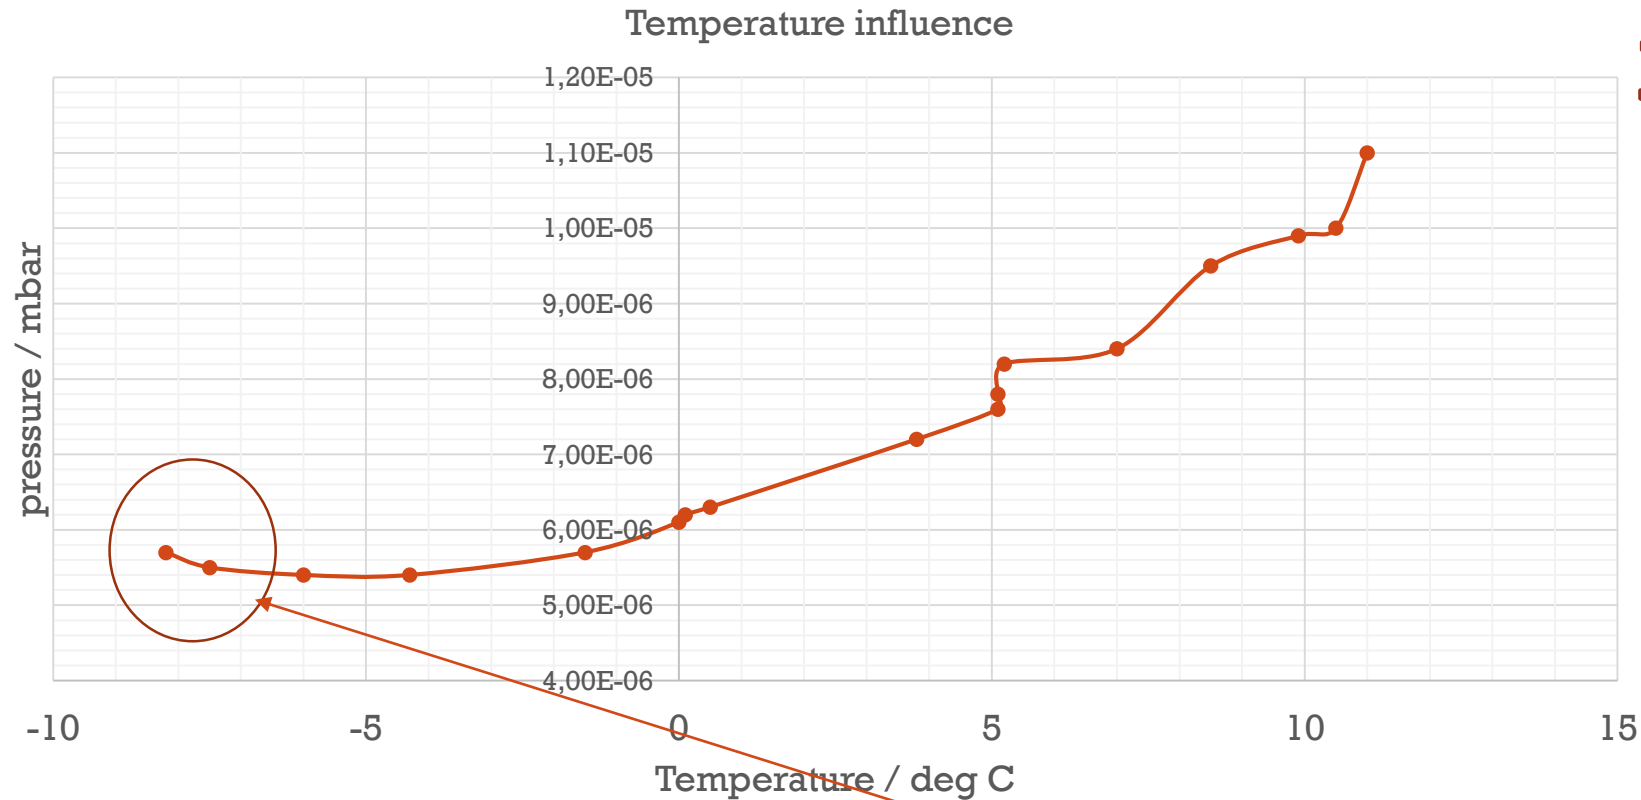
**Just changed temperature!
(over 1h)**

**Pumped for 180 h to Minimum:
p ~ 5.7E-06 mbar
T ~ -8.2° C (although set to -10 deg C)
→ Freezing issue in the chiller**

**Freezing
release**

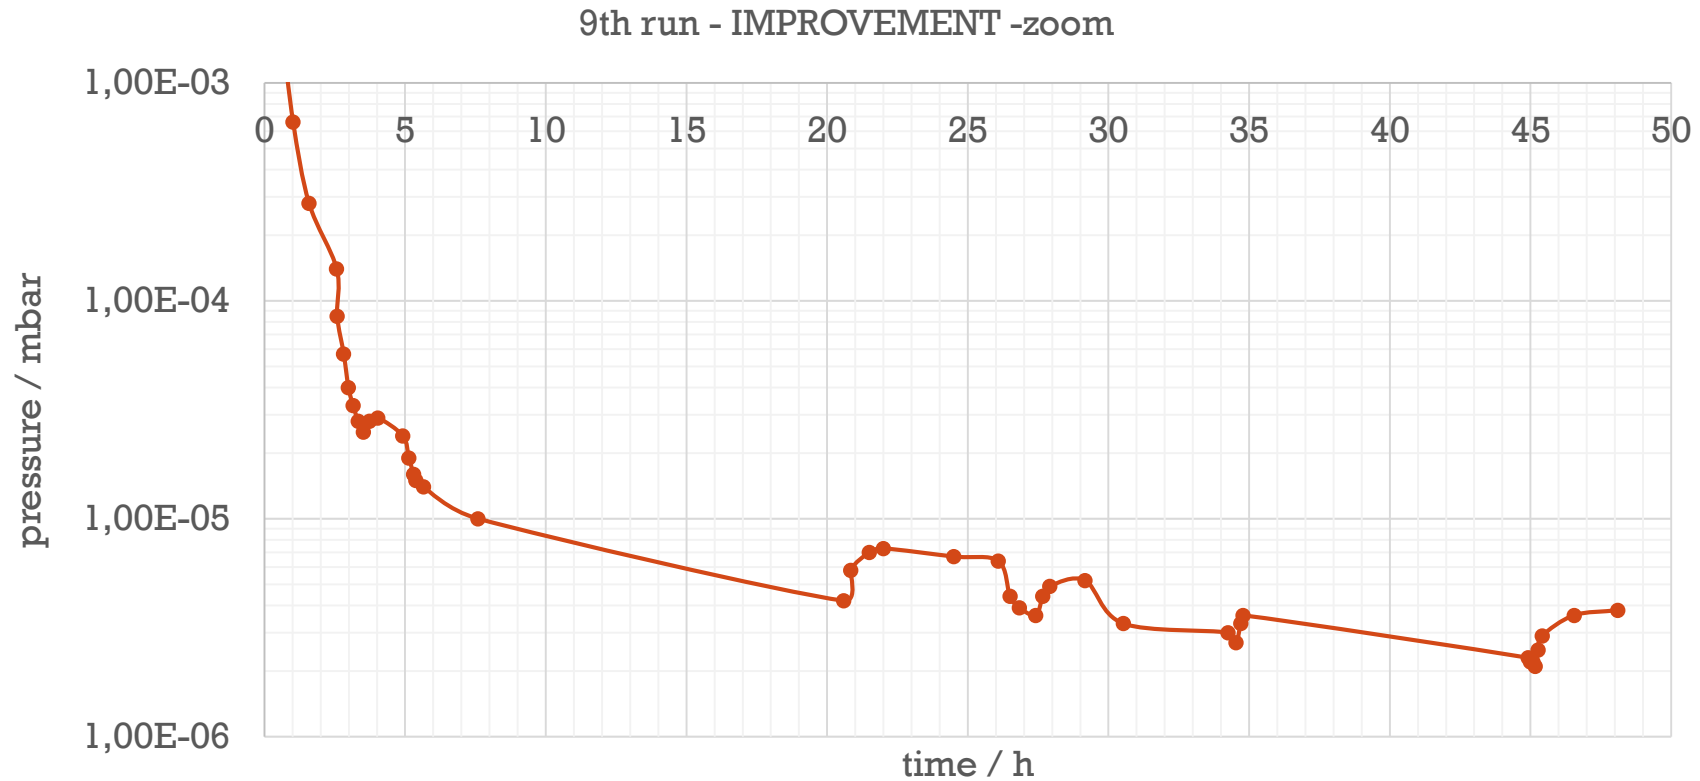
Minimum:

$p \sim 2.2E-06$ mbar

$T \sim -12.5^\circ \text{C}$ (reached -14.8°C)

$\rightarrow 1E-05$ took 7 hours \rightarrow chamber was open for 45 min (Si-Det mounting)

**Coolant
exchanged
+
Gauge closer to
TP2
+
Opening
procedure**

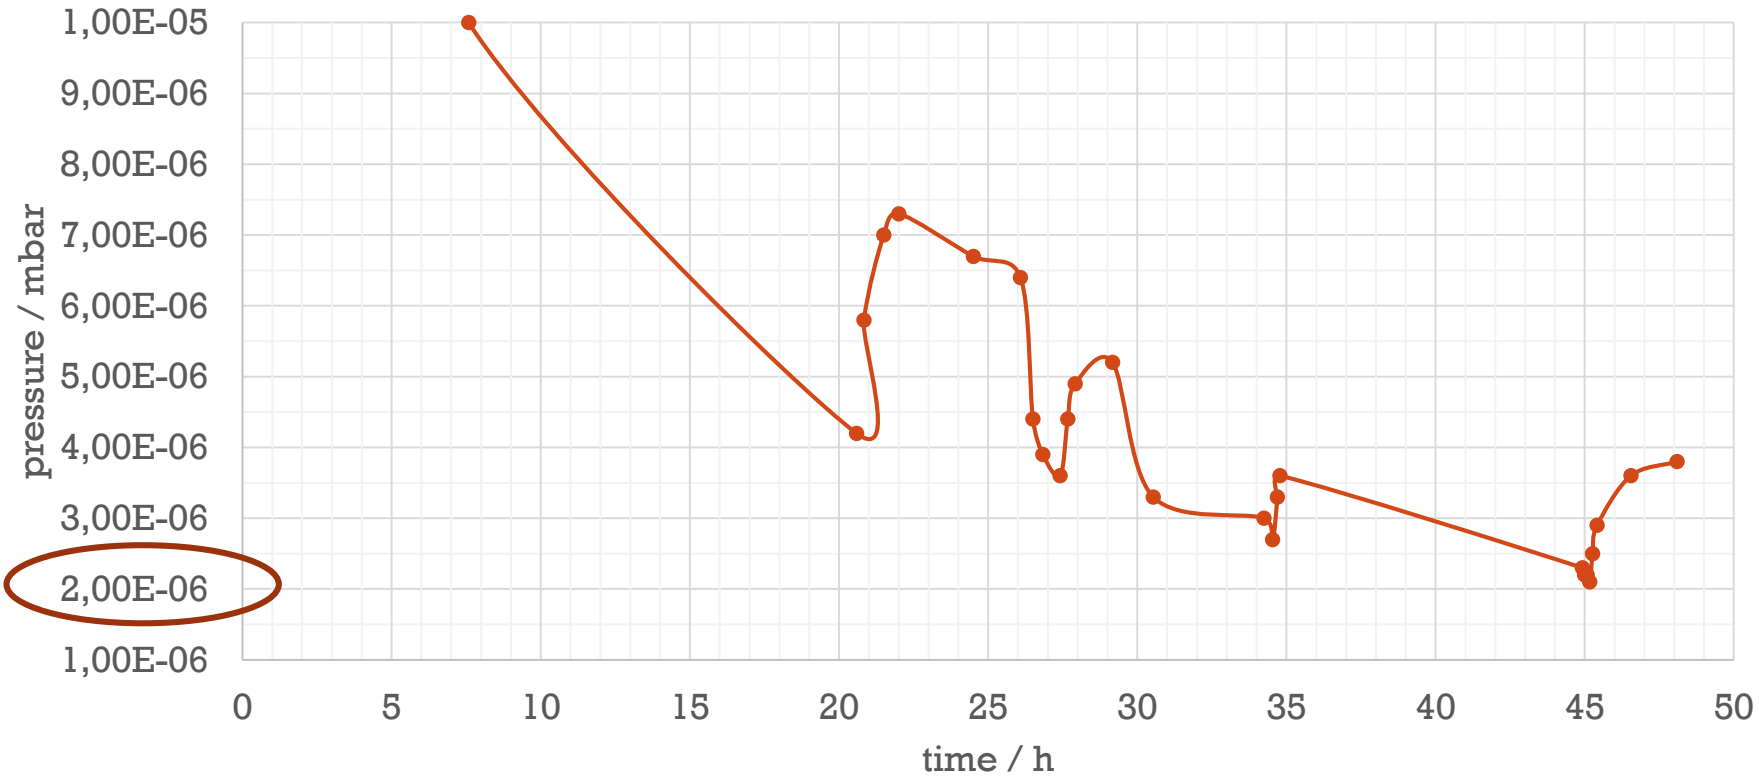
9th run - IMPROVEMENT -zoomII

Minimum:

p ~ 2.2E-06 mbar / ~4E-06 mbar with preamp ON

T ~ -12.5° C (reached -14.8° C) → constant with preamps on

→ 1E-05 took 7 hours → chamber was open for 45 min (Si-Det mounting)

**Coolant
exchanged
+
Gauge closer to
TP2
+
Opening
procedure**

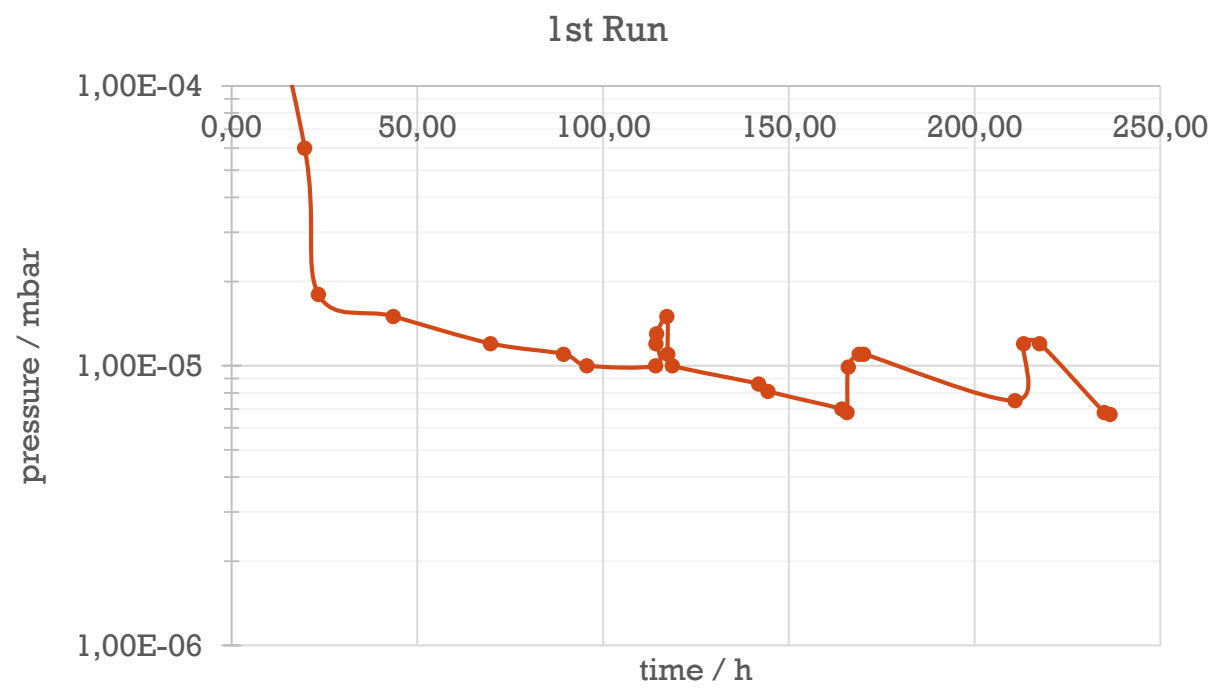
Minimum:
p = 6.7E-06 mbar (>6-9 days)
T ~ -2.4° C

→ Add alcohol

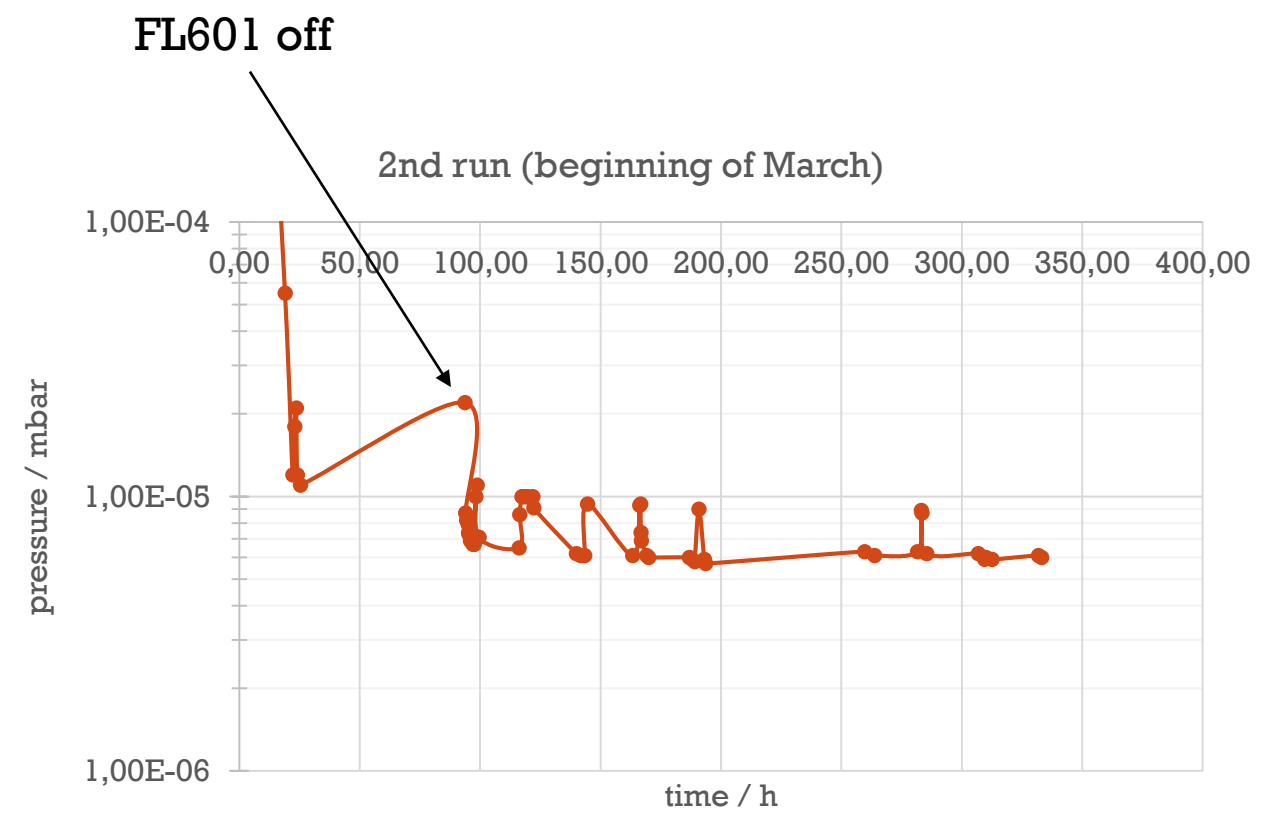
Minimum:
p = 6.0E-06 mbar
T ~ -10.0° C (>100 h)

→ Additional Turbopump (TP2)

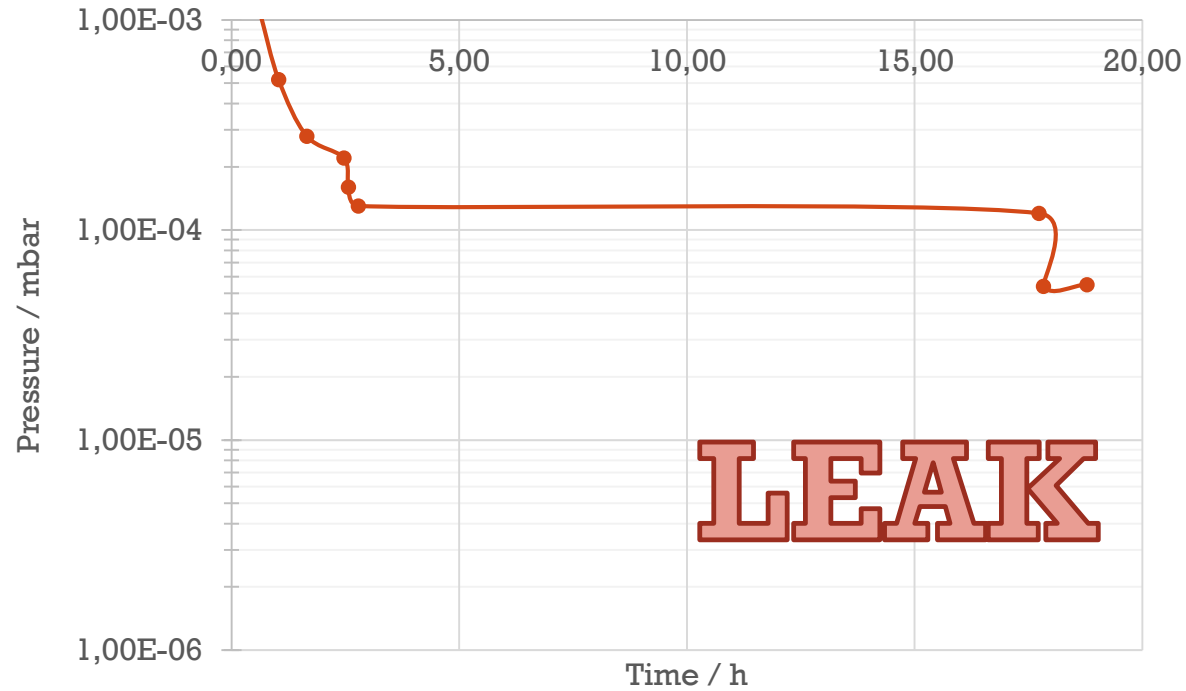
3rd try - loose screw and dust on o-ring

Minimum:
p = 5.5E-05 mbar
T ~ -9.7° C

→ Cleaning and check!!!

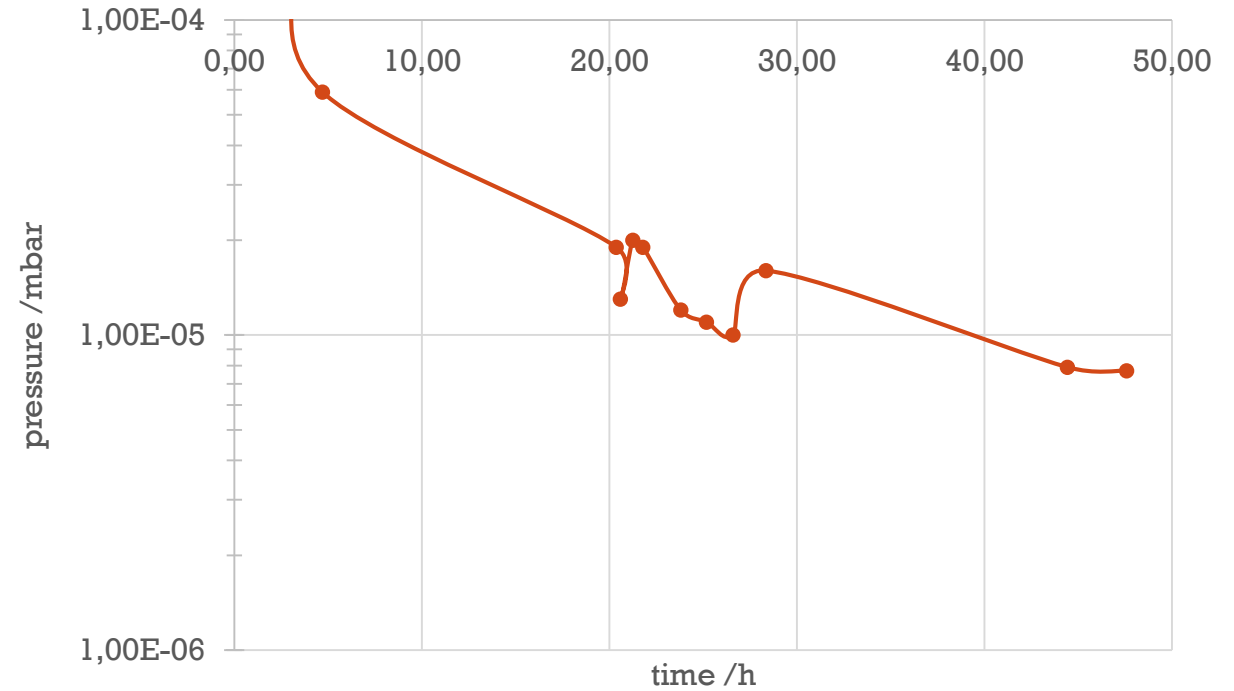
4th - one preamp board less

Minimum:
p = 7.7E-06 mbar
T ~ -7.7° C

Less chamber load → <45h
(properly ~30h)

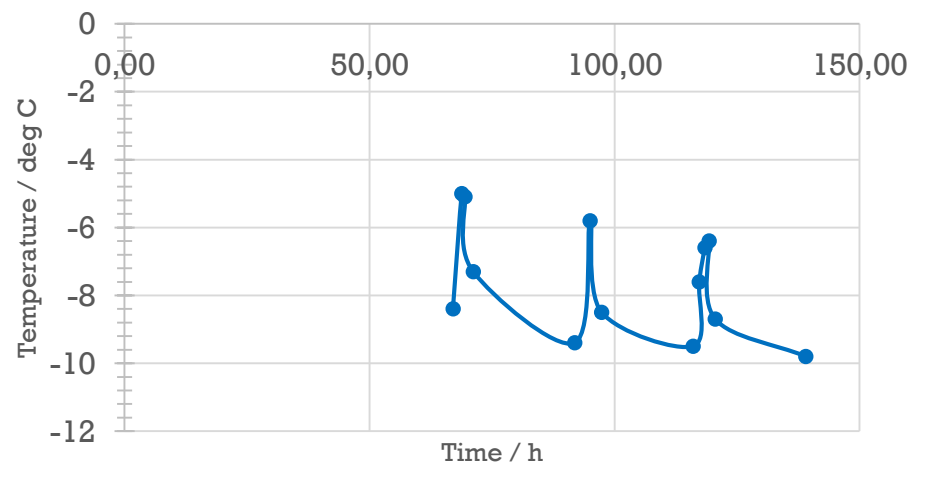
5th run - Temperature

Minimum:

$p \sim 6.0E-06$ mbar

$T \sim -9.8^\circ C$ (needed some heating cycling)

→ not always improvement with preamp heating.

→ Influence of room temperature

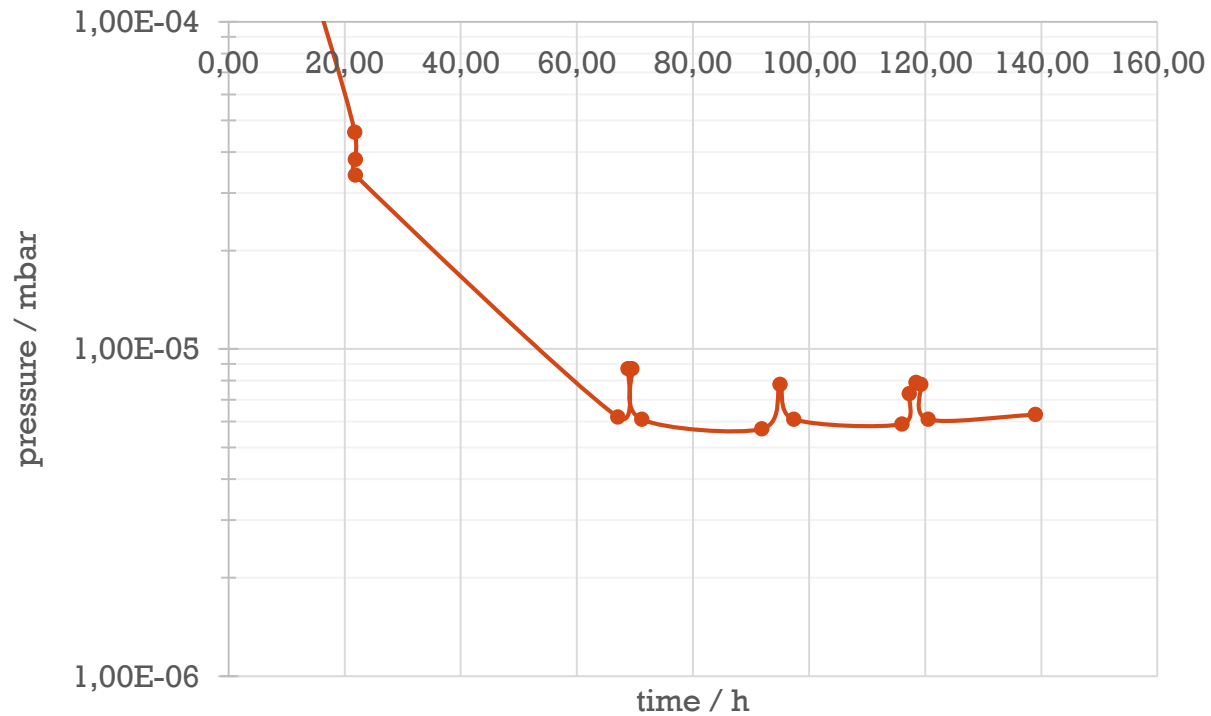
5th run - over weekend

Minimum:

p ~ 6.0E-06 mbar

T ~ -9.8° C (needed some heating cycling)

→ not always improvement with preamp heating.

→ Influence of room temperature

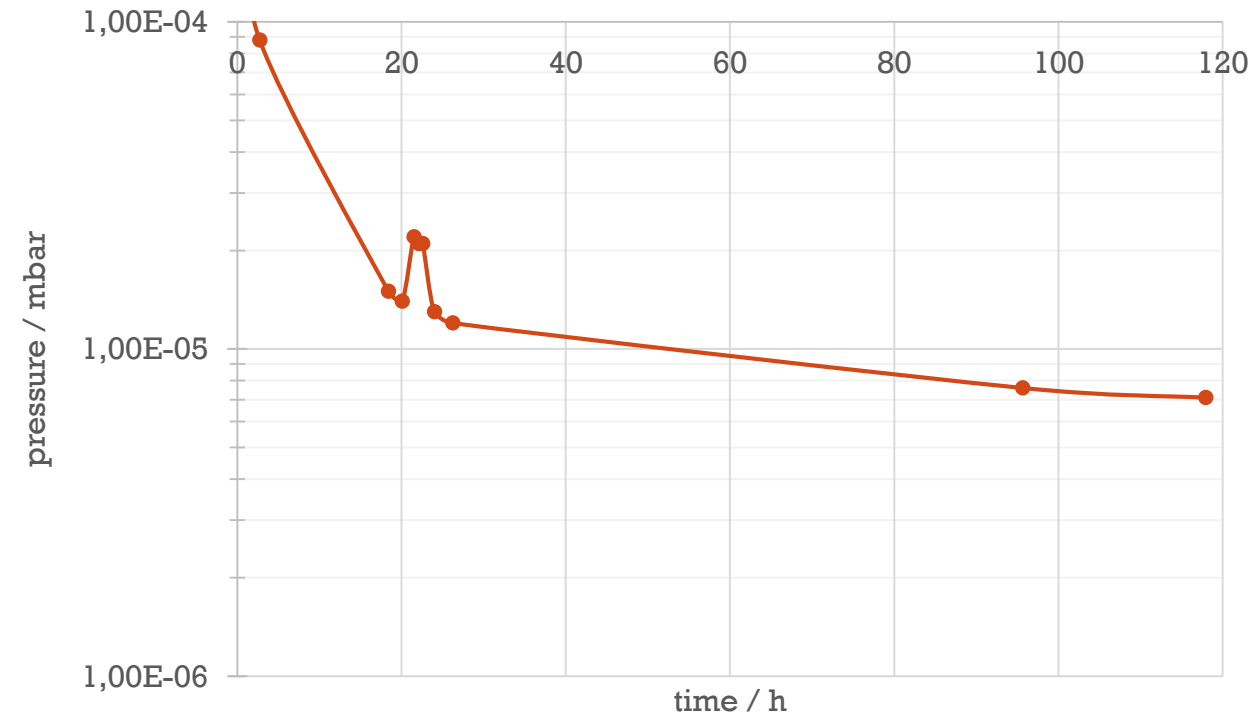
6th run - hardly preamp heating

Minimum:

p = 7.1E-06 mbar (120h)

T ~ -7.7° C

**Preamp heating improves at least
pumping time**

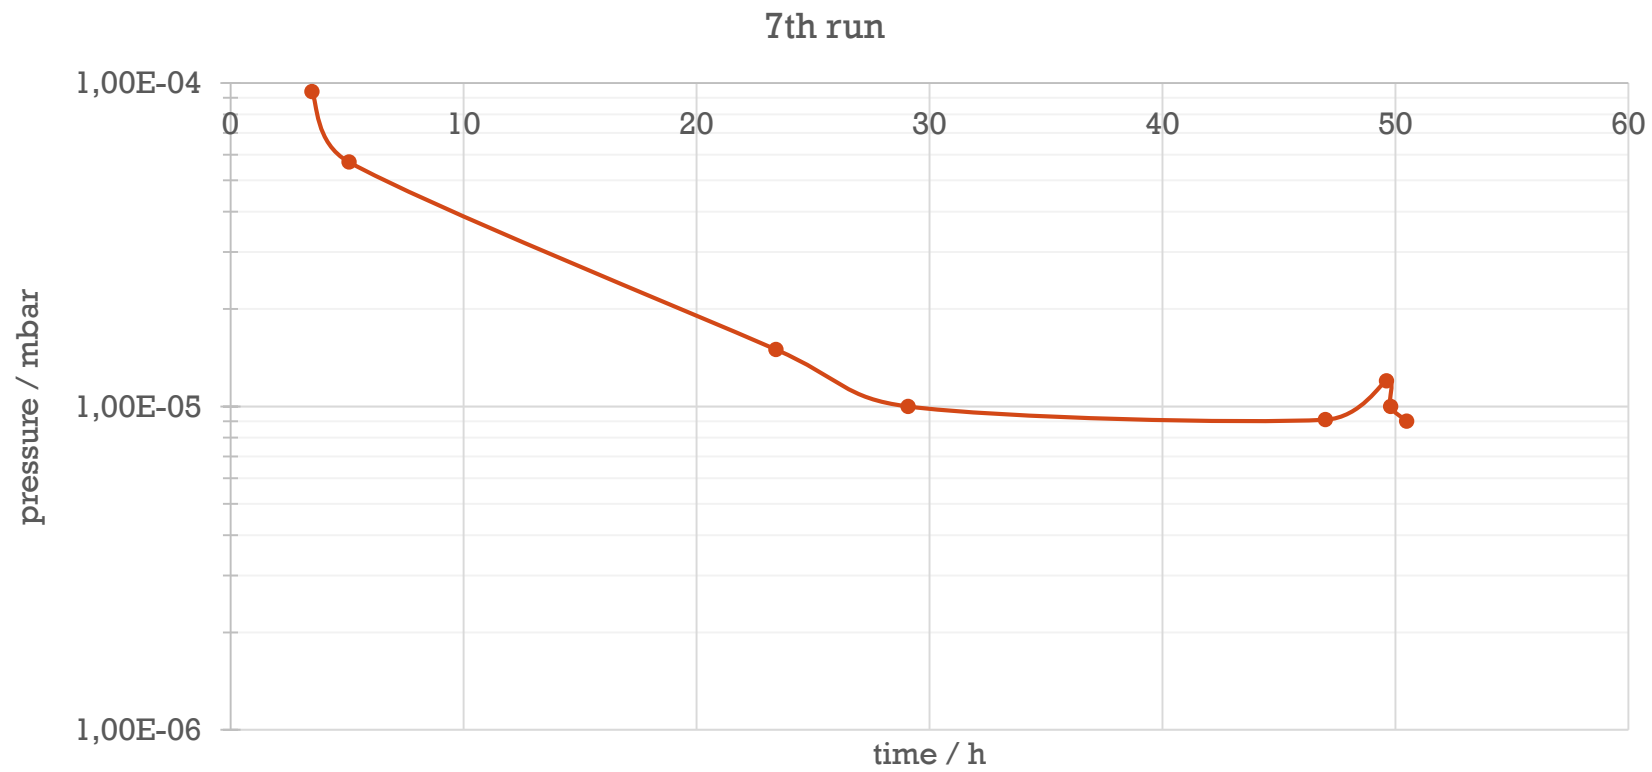
Minimum:

p ~ 9.0E-06 mbar

T ~ -9.8° C

→ Influence of TP2 ?

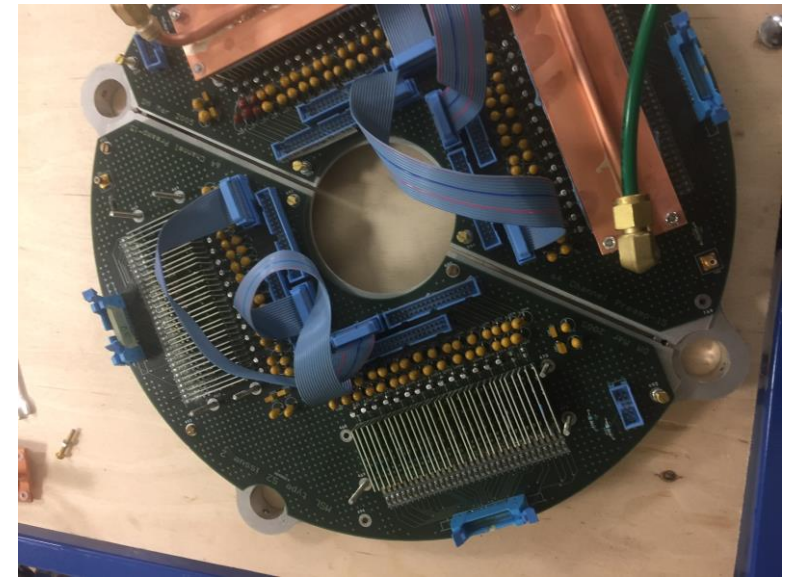
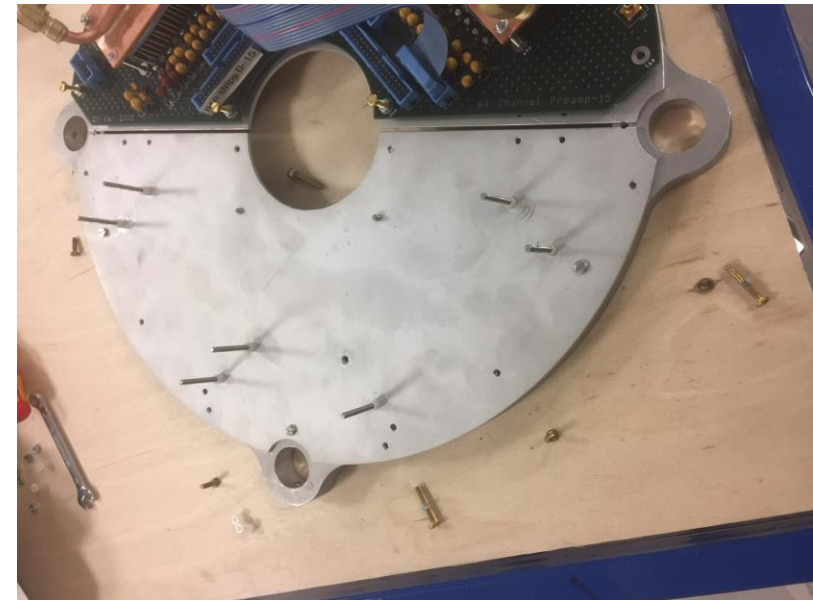
- 4 broken channels in a row on the old Upstream preamp board U1 – U4
- Request: 128 channels UPSTREAM
- 64 channels DOWNSTREAM
- → exchange UPSTREAM and DOWNSTREAM boards and removed the old U1-U4

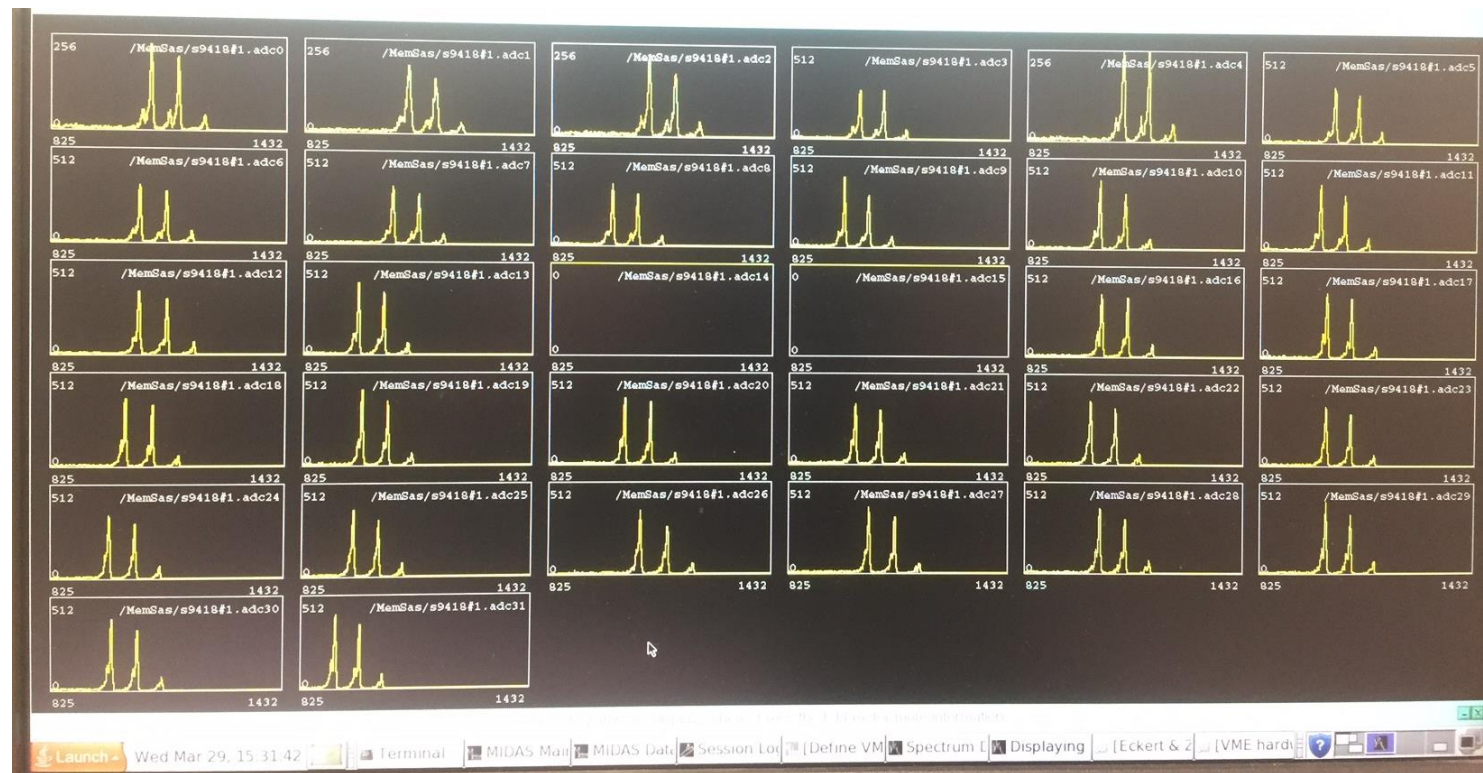
- Details on ELOG
- FWHM of alpha source:
 - Problem with #1 adc14, 15 ;
#2 adc 7;
 - #4 adc 6, 7
 - Cabling issue maybe on #2/4 adc 7
