^{41}Ca Experimental setup

Tuesday 8th of July

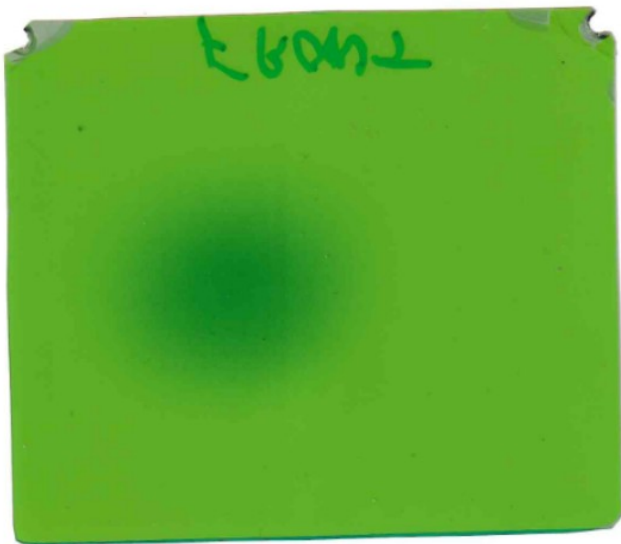
First alignment

The first step was to realign the chamber with the results from the gafchromic.

The chamber was moved in order to center the sample, because it was shifted at the beginning. Now the sample is center with the beam.

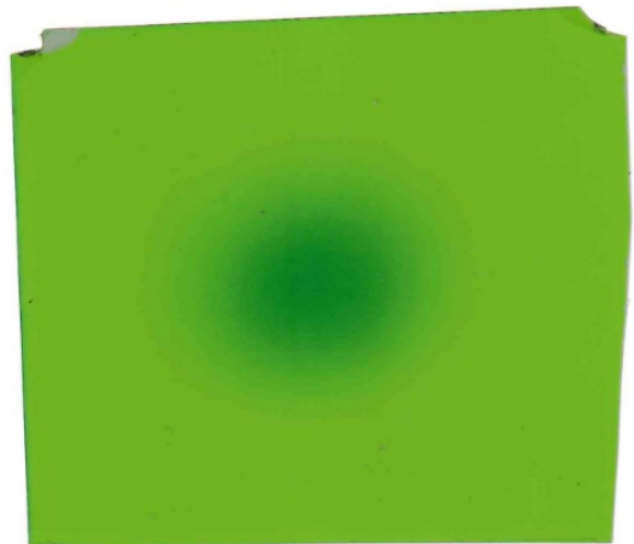
Final Aligment

Checking the signals, we observed that the noise was not there, the detectors were working better and we adjusted the parameters in the DAQ by running with a lithium run for an hour. At the end of the day, we put the second gafchromic to confirm that we were well align, as we can see in the right picture above.

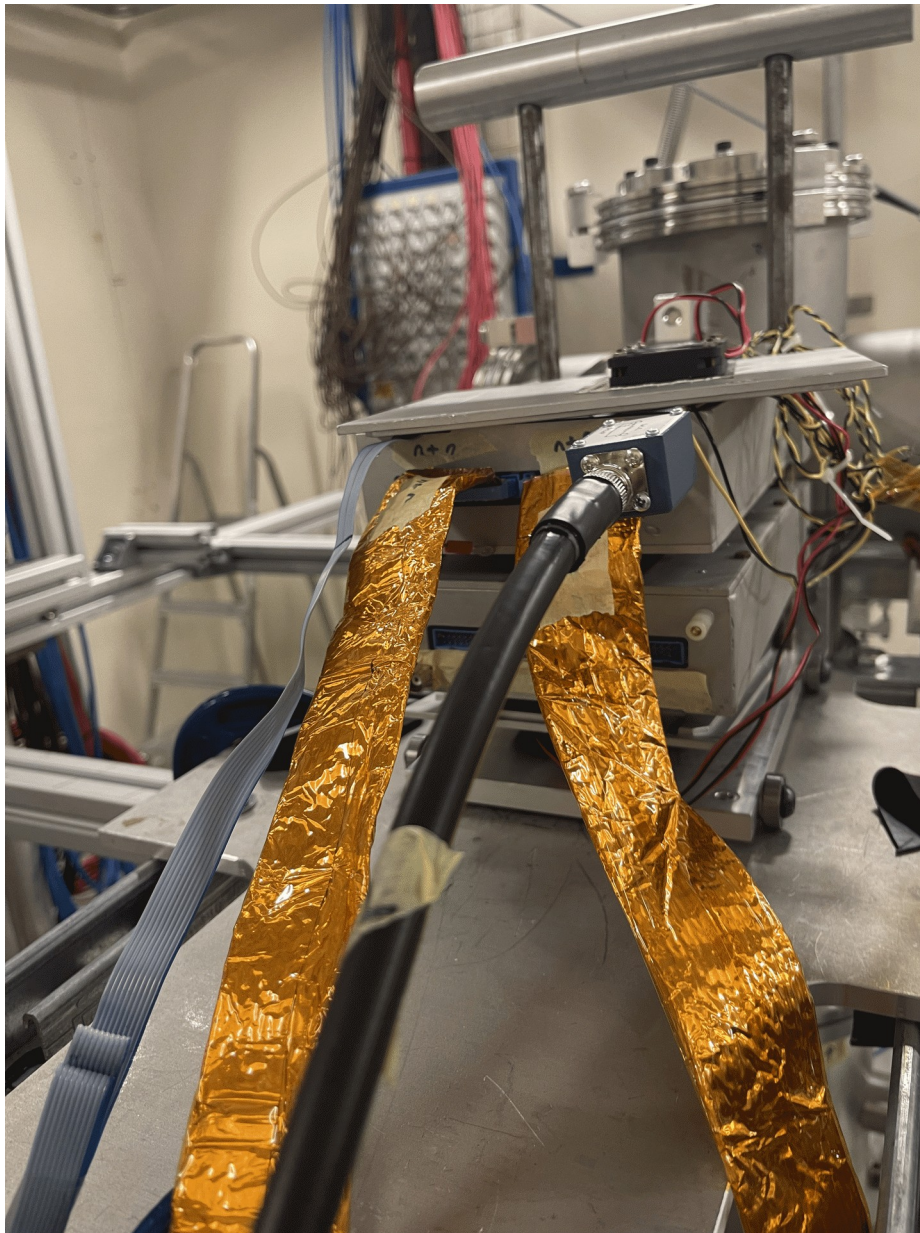
Then, we moved to the cable that connect the detector with the PreAmp and we tried three different cables in both PreAmp and it didn't work either. The problem was the same and for the same channels.

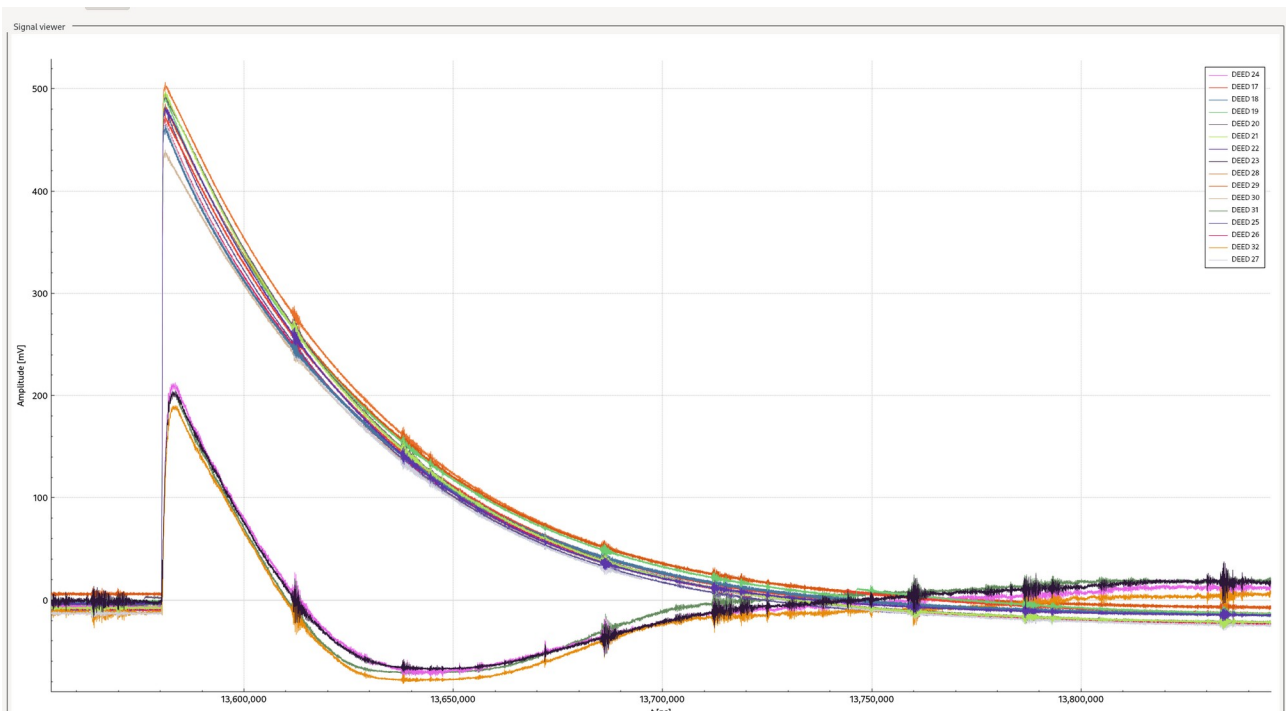
We changed the DSSSD detector as well, getting the same results as before. In order to have an idea, this was how these four channels look like.

It's clear the attenuation between these four channels and the others one.

As the problem didn't look to be in the PreAmp or in the detector itself, we replaced the cables from the PreAmp to the MCA.

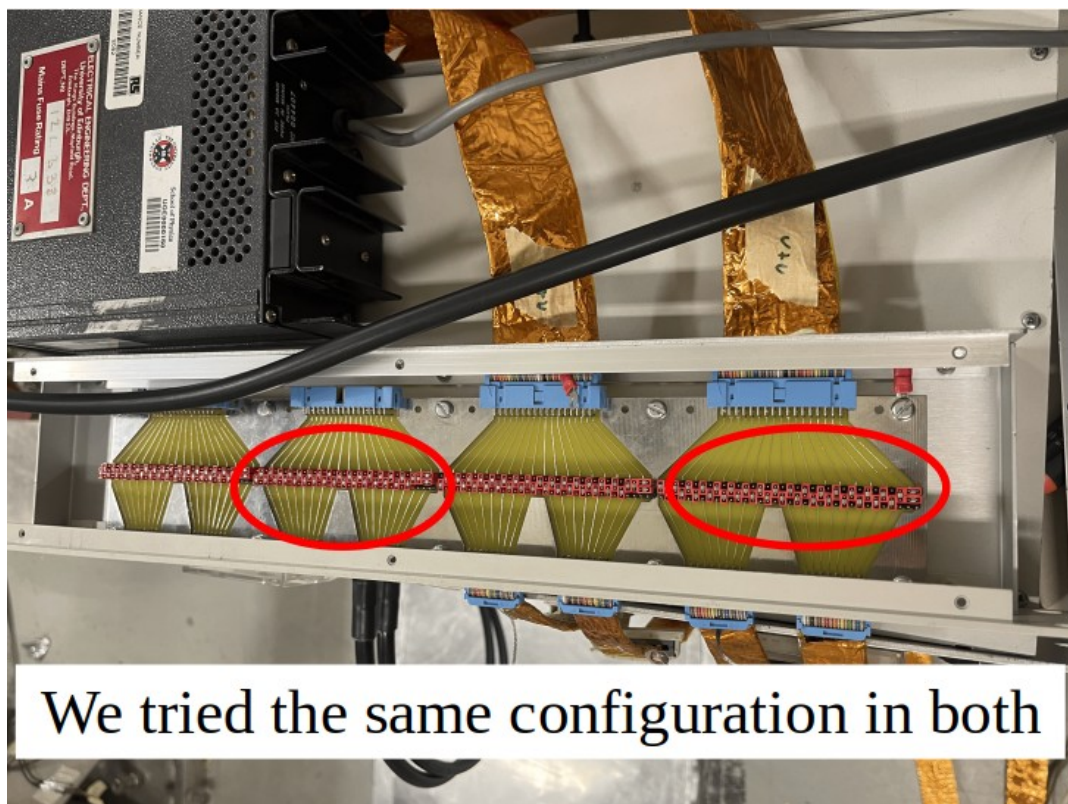
Then, we checked the cables again to be sure that the problem was not there, we changed the cables from the PreAmp to the MCA, but the problem was still there. We tried as well to used a different connection in the picture attached below.

The situation after all these modification is still the same and for the Boron run we are not able to see signals from the FileDisplay.
