AIDA test

AIDA tests: February 2005

Installed DSSD 2977-7 and ^{207}Bi source. 3 modified Kapton cables.

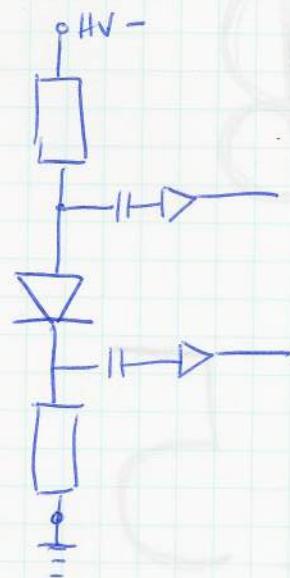
Jumper settings of adapter PCBs

-ve P+N strips to reverse bias diode
connected to pins J9 G/R (or J10 depending on side)
LNK/S not connected

the n+n sides have both LNK/S pins connected to ground $\xrightarrow{\text{bias}}$

Lk7/3 connect PCB ground to Kapton ground screen
→ connect on all active cards

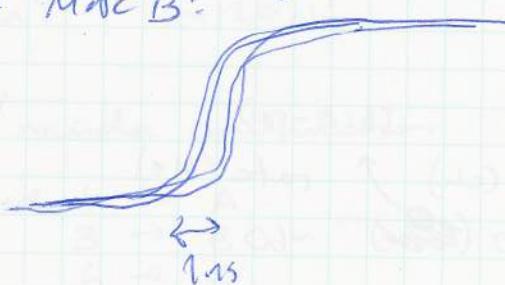
We have $\sim 1\text{ns}$ jitter in 25 MHz clock from MACB:

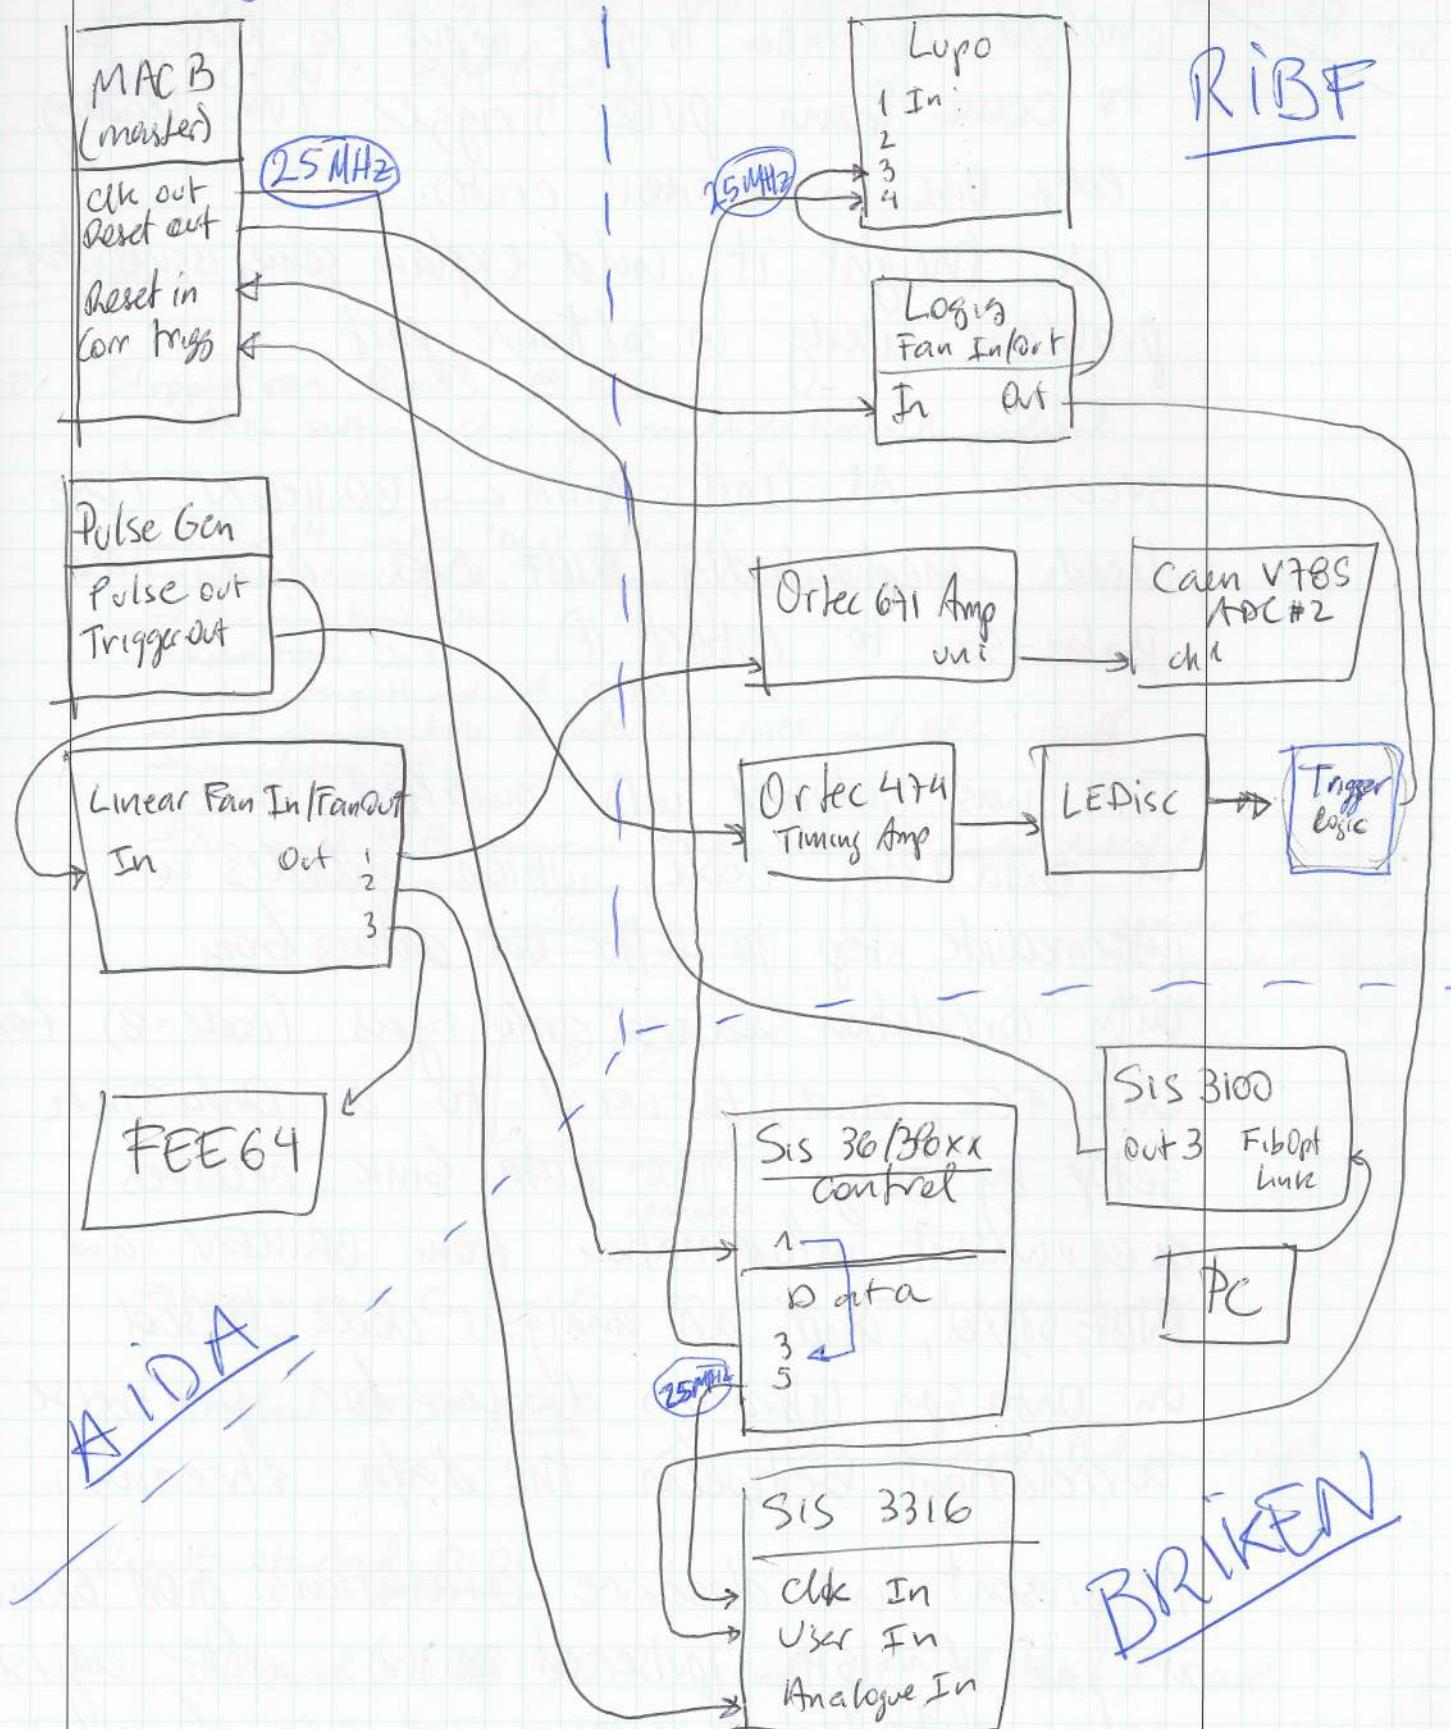
Settings for DAQ correlation test

changed correlation trigger input to MAC to come from pulser trigger (via leading edge Disc in WASABI crate).

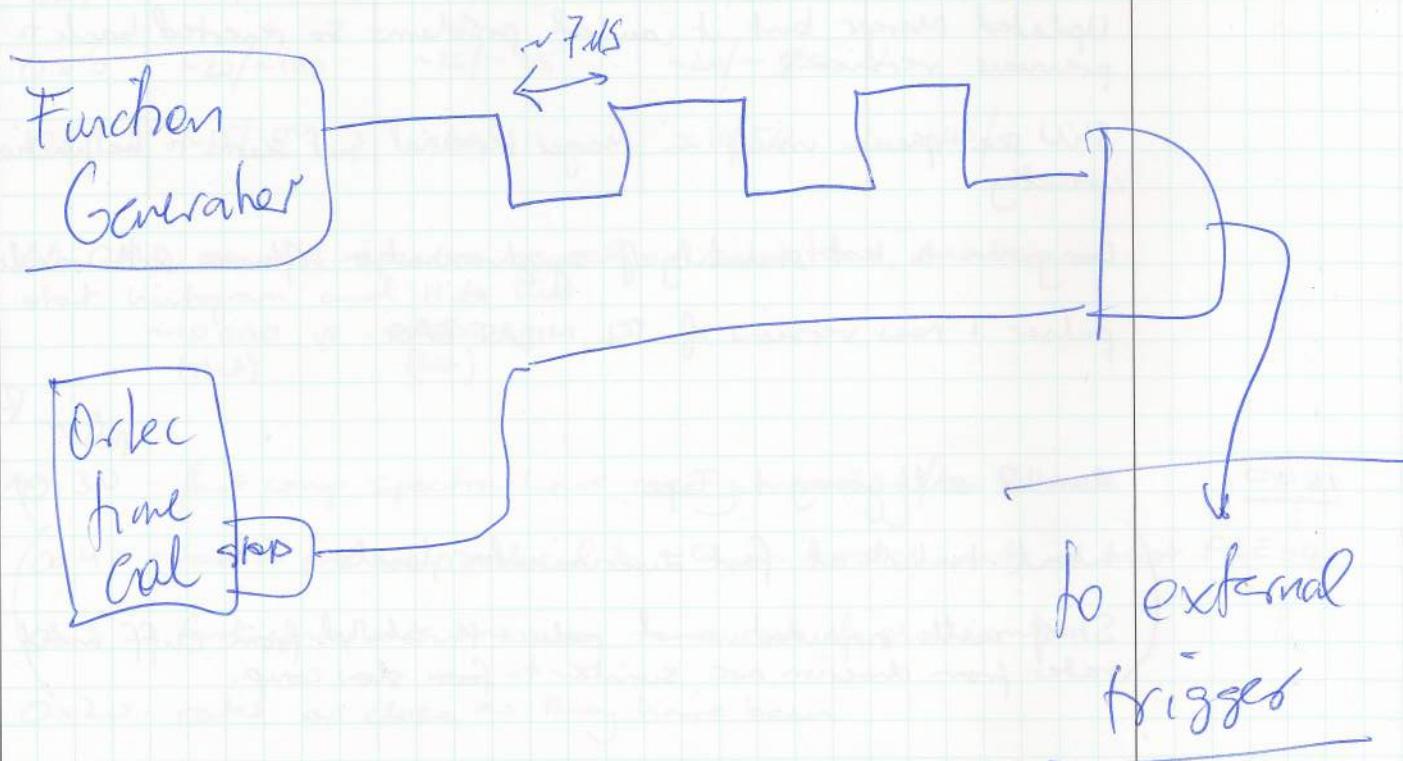
Now pulser triggered externally

changed pulser trigger to only external
before a 25MHz internal trigger was still
enabled.
(R14-)
